Evaluation of Installation Damage of Geotextiles. A Correlation to Index Tests

R. Diederich

DuPont de Nemours Luxembourg S.A.

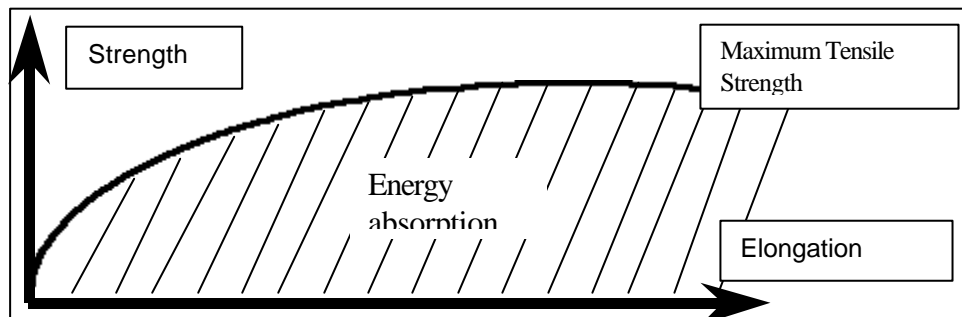
Figure 1: Energy absorption

Energy absorption is defined by the area under the stress - strain curve
The energy absorption (kJ/m) is the maximum energy a Geotextile can absorb before failure.

Instead of defining the absorbed energy as the area under the stress-strain curve, the Norwegian, Swiss and French proposals, all take a simplified theoretical approach and define energy absorption as the product of tensile strength (T) and elongation (ϵ_f) at maximum strength.

$$e = \frac{1}{2} T \cdot \epsilon_f$$

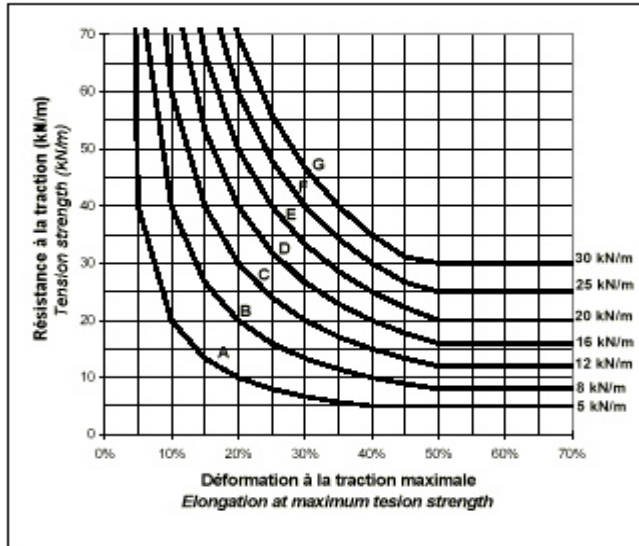
Figure 2: French energy absorption concept proposal: J.C. Blivet, Rencontres Bordeaux 1999

The principle of the French recommendation is to use a minimum strength at a given elongation, but allows compensating lower elongation by higher strength thus resulting in the same energy absorption or same damage resistance.

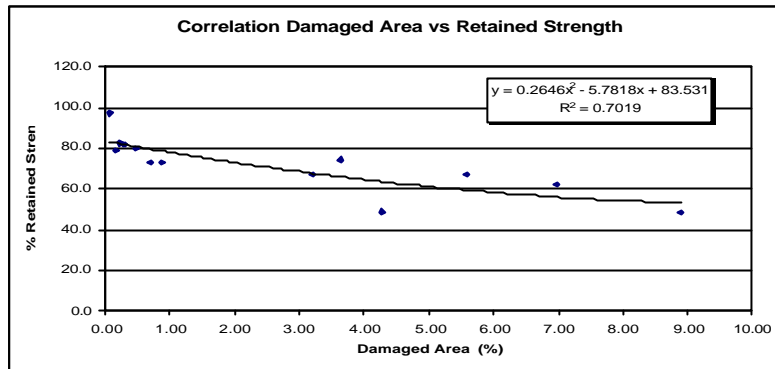
Figure 3: Correlation between damaged area and retained strength

The correlation of the total damaged surface area (%) with all of the index tests has been compared. A good correlation has been observed between the damaged surface area and retained strength.

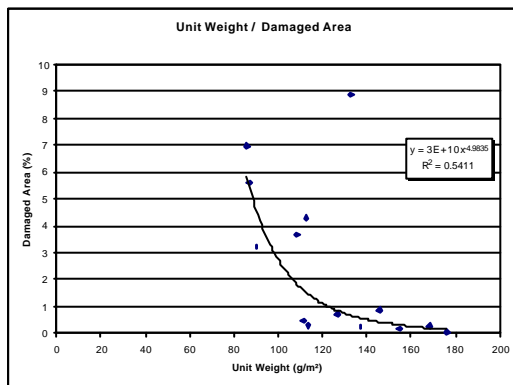
fig:4 Correlation with Area Weight

Unit weight and thickness are descriptive properties only and do not provide any information relating performance when comparing different products. Only for products of the same “family” (i.e. manufactured according to the same process), is the damage resistance directly related to the uniform spread of its unit weight. At a uniform external stress, it is the weakest parts of the geotextile, which are the first to be damaged. For specification purposes, average unit weight and thickness are however irrelevant, since the unit weight to achieve a given performance depends on the different manufacturing technique.

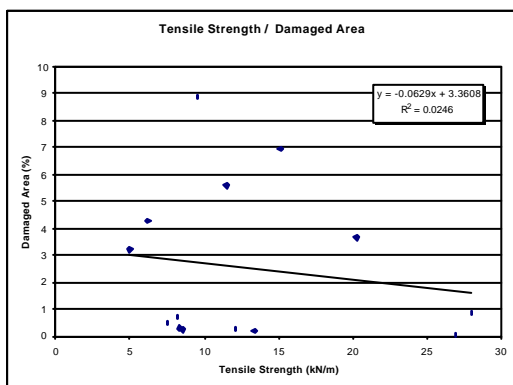
fig:6 Correlation with Tensile Strength

No correlations were identified between the damage and any of the mechanical properties such as tensile strength, CBR puncture resistance, grab tensile strength and tear resistance.

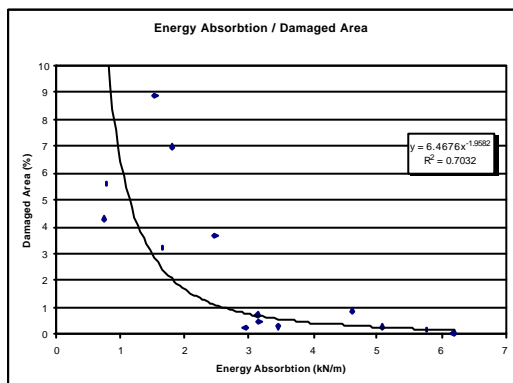
fig : 10 Correlation with Energy absorption

Excellent correlation has been found between the damaged area and the energy absorption (defined as the area under the stress-strain curve determined according to EN ISO 10319). Under the used test conditions it is clearly seen that all geotextiles with an energy absorption of less than 3 kN/m have showed significant damage, whereas those geotextiles with an energy absorption greater than 3 kN/m survived these conditions without major damage.

A clear correlation between energy absorption and damage resistance has been found for all geotextiles tested, independent of their manufacturing process and physical structure.

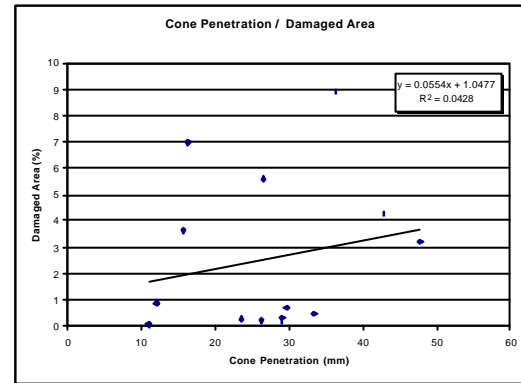
fig : 11 Correlation with Cone Penetration

Although dynamic puncturing (Cone Penetration) is usually seen as a performance test simulating real conditions, little correlation has been observed during this test. As the dropping height in the trial was however limited to 50 cm, the cone penetration test may have a higher significance as the aggregate dropping height increases.

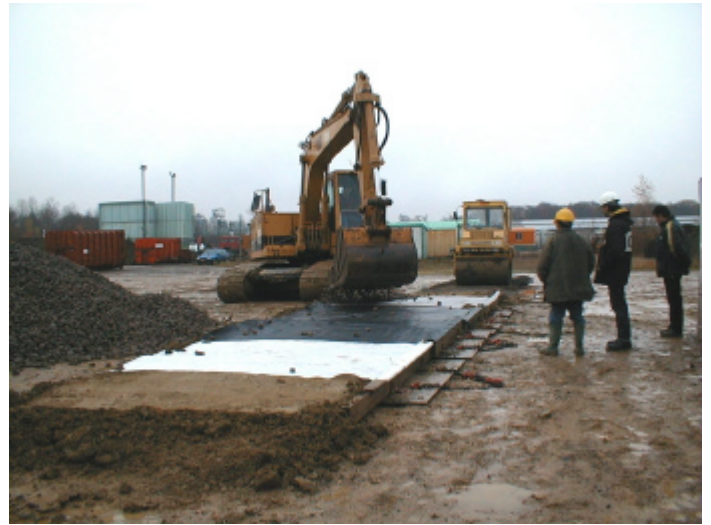
Installation

Steel plates (2 x 2.50 m) with steel chains at the edges were constructed. Compacted soft clay subgrade from the local site was placed on top of the plates at a height of 25 cm. A 2 x 2 m geotextile sample was laid directly on the subgrade and covered with a 25 cm high layer of high furnace slag (40-60cm diameter) dropped from a height of 50 cm. The system was compacted with a 7-tonne vibratory roller with 4 passes (forward and backward).

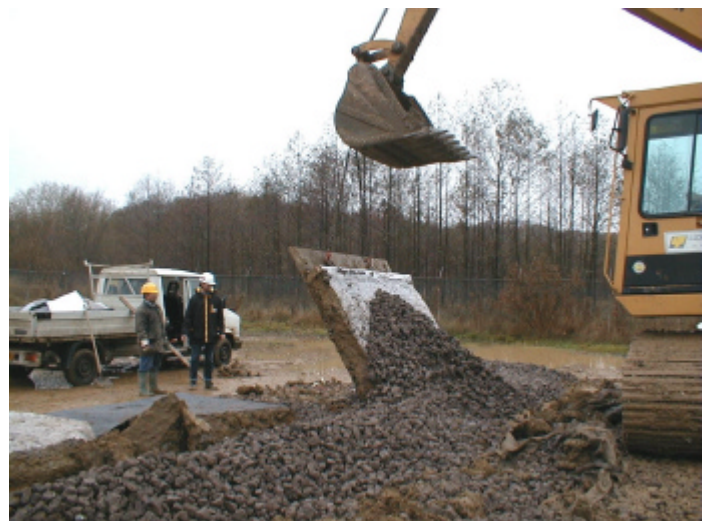
Extraction

Following compaction, the steel plate with soil/geotextile system on top, was gently tilted and lifted, so that the aggregates slid along the geotextile without creating any additional puncturing or damaging. All Geotextiles could be installed and extracted under identical conditions.
